**December 21, 2005**  
**MEMORANDUM**

Subject: Site inspection of Dominion – North Anna Power Station VA0052451

Dominion – North Anna Power Station/VA0052451  
Site visit October 14, 2005

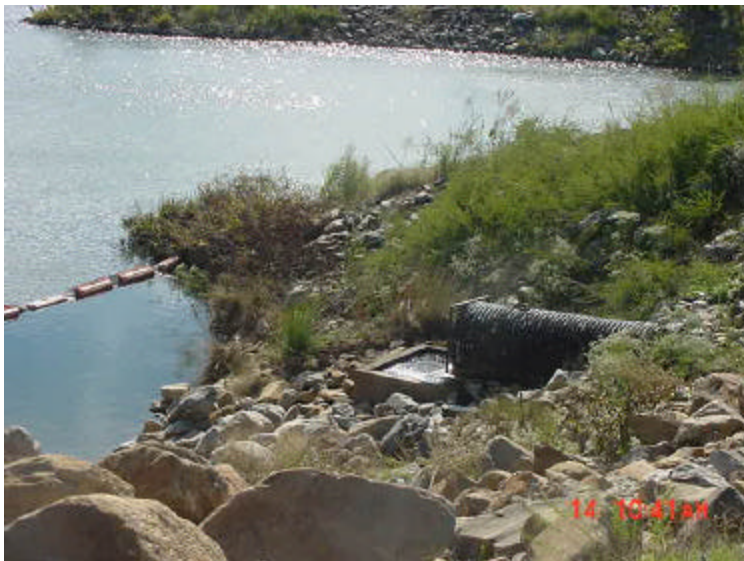
Outfall 104 – Oil/Water Separator & SW

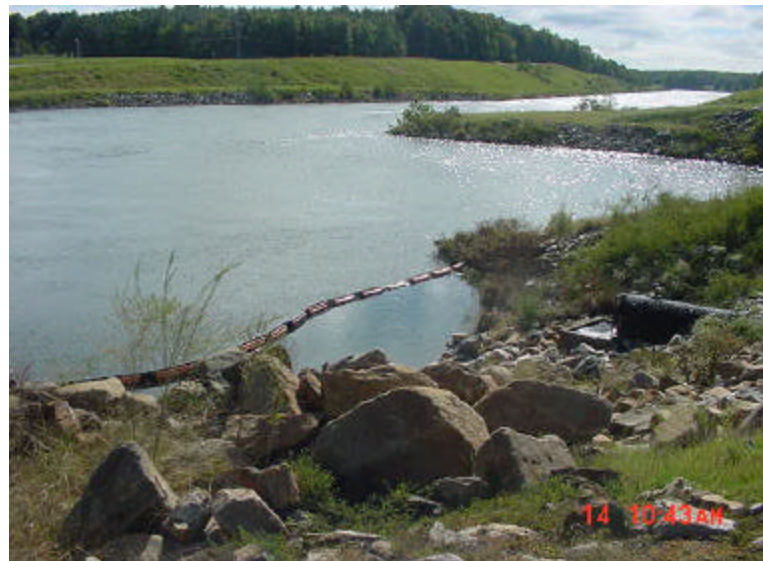
Outfall 104 – Far view

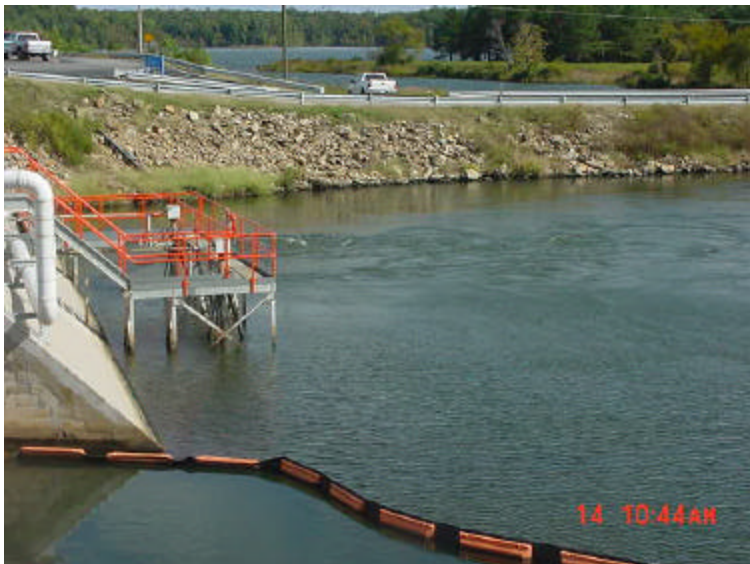
Structure for Units 1&2

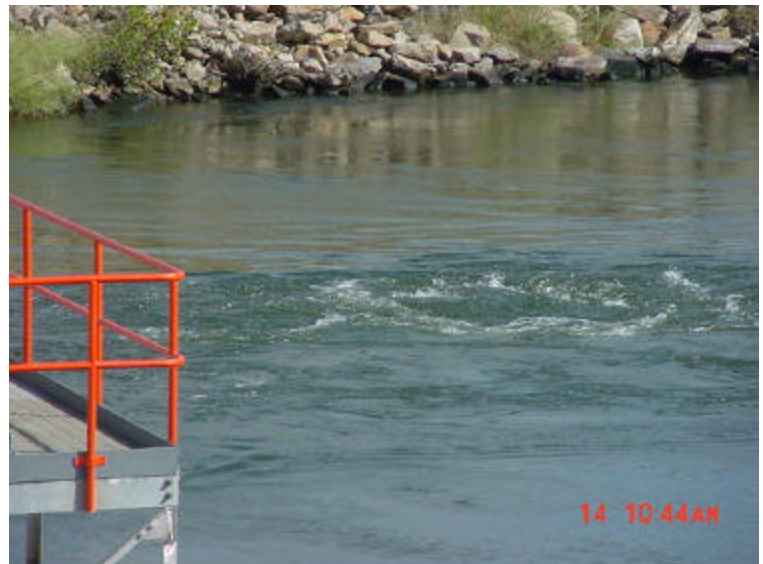
Detail of structure for Units 1&2

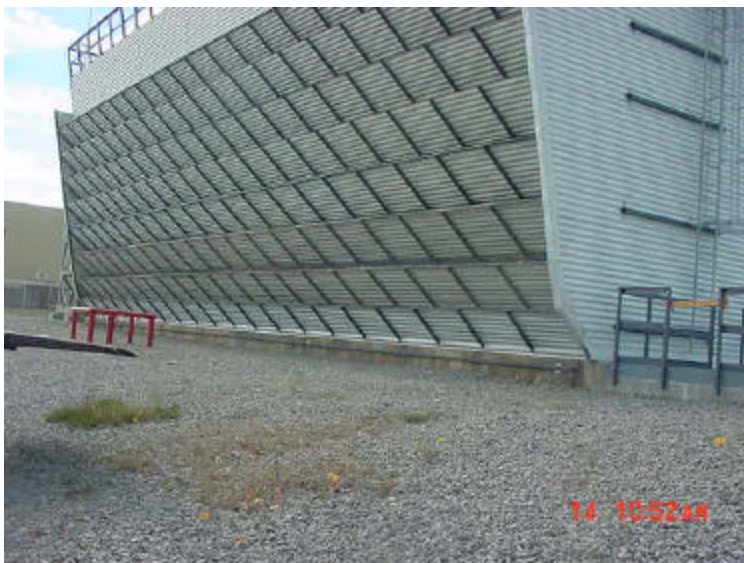
Bearing Cooling Tower (Outfall 105 is in basement)

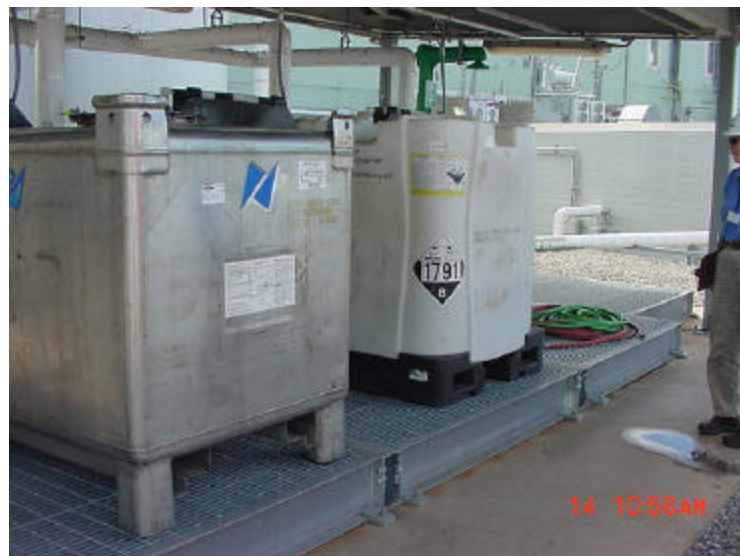
Chemical additives for Bearing Cooling Tower

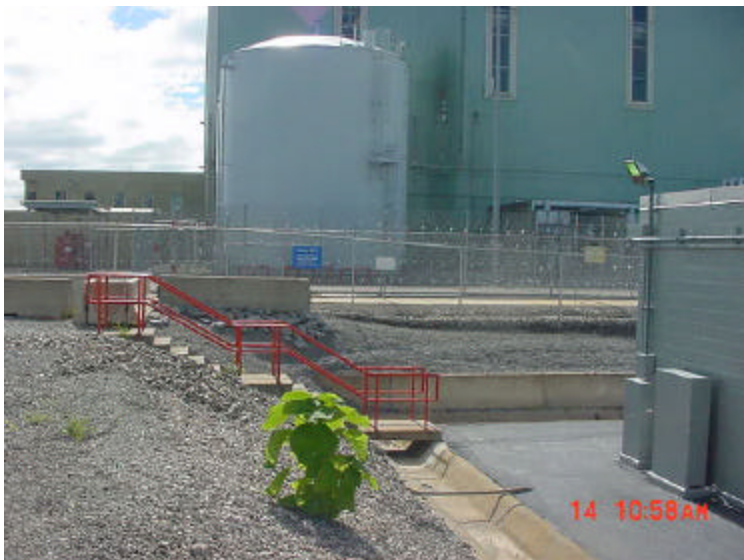
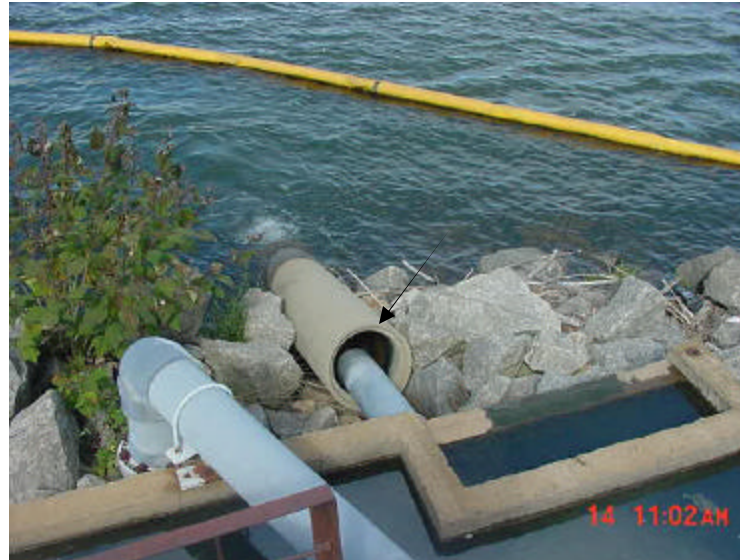
Outfall 020 – Reject for RO

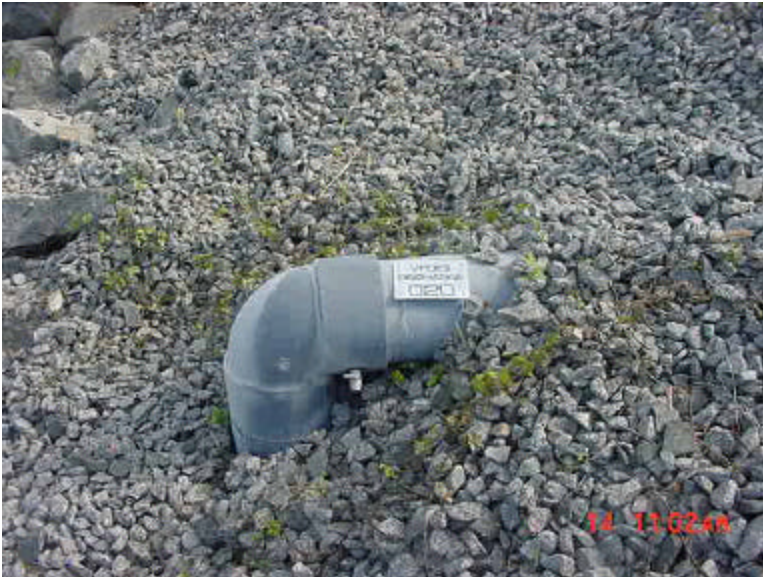
Detail of pipe that leads to Outfall 020

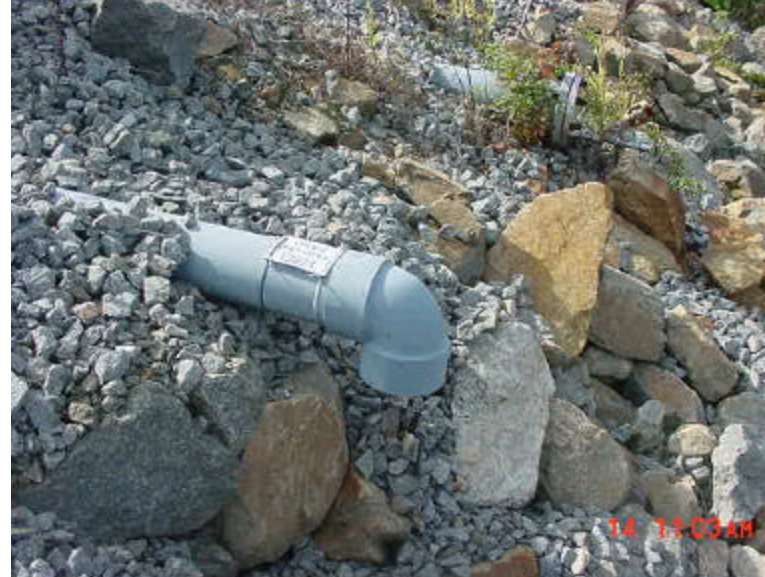
Outfall 021 – Reverse Osmosis Drain Line

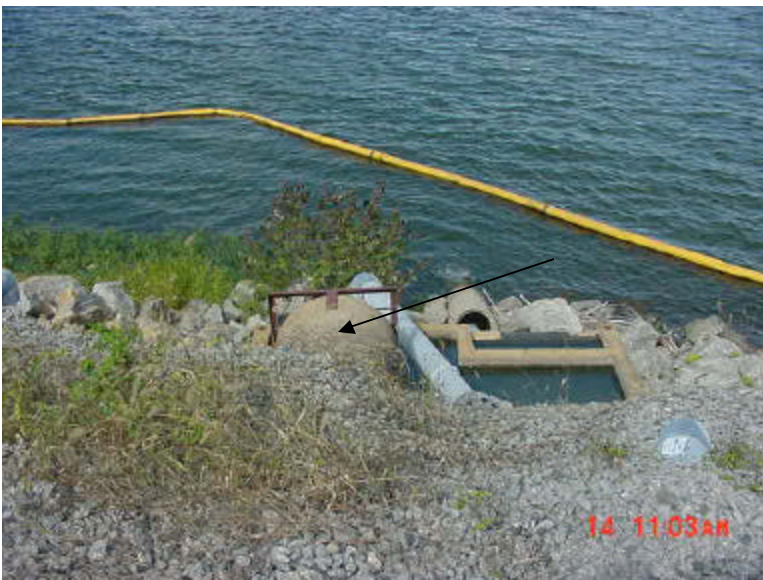
Outfall 013 – Turbine Bldg Sump 1 & 2 and SW

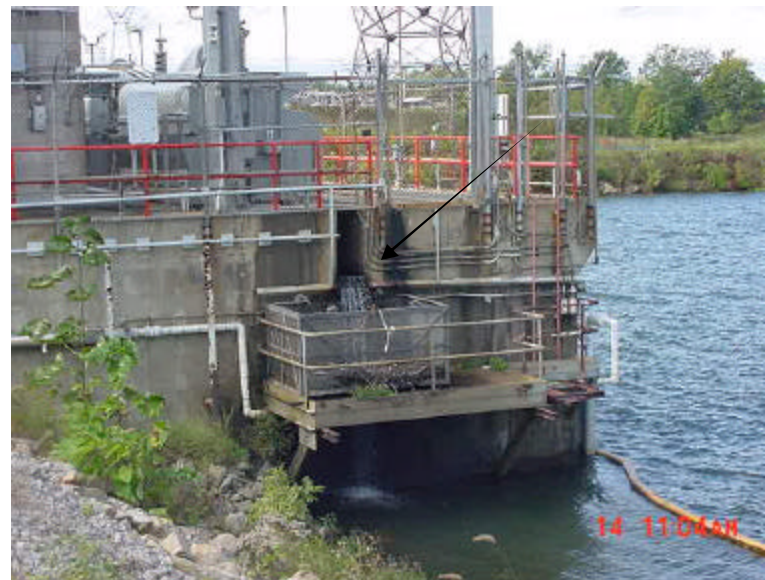
Outfall 016 - Intake Screen Wash Water

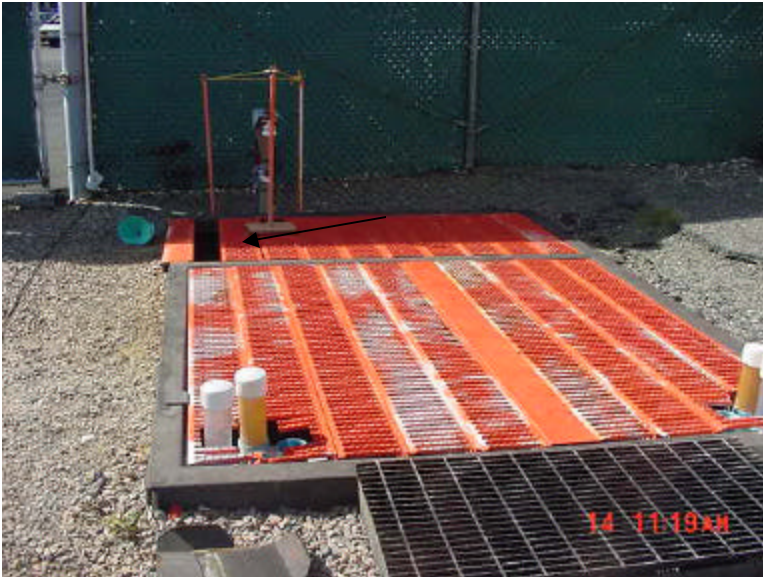
Outfall 111 - Main Sewage Treatment Plant: 2 chlorine contact tanks and final effluent. Samples taken at weir shown at arrow.

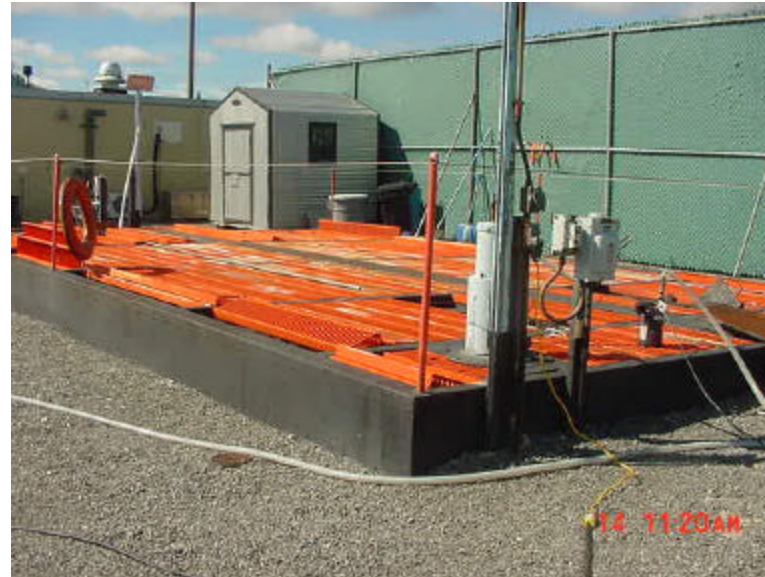
Clarifiers

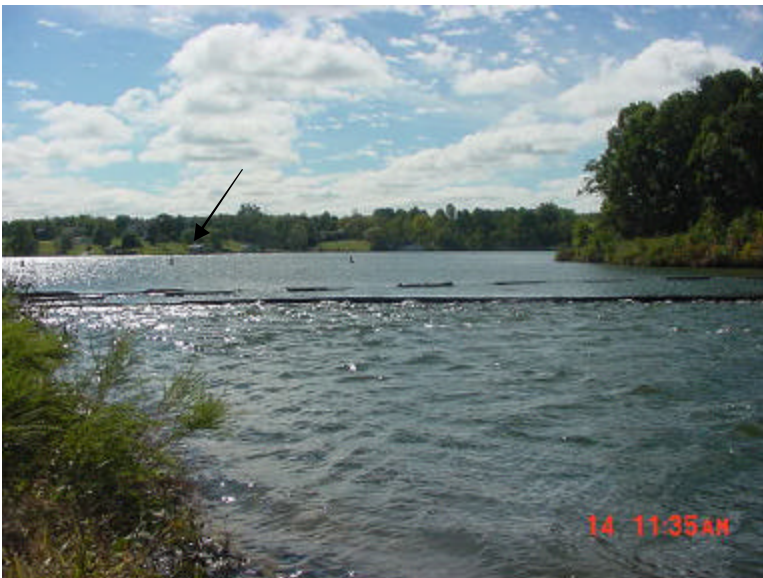
Discharge Canal (ends at buoys). Lagoon 1 is in distance beyond buoys. Thermal monitoring performed at buoys.

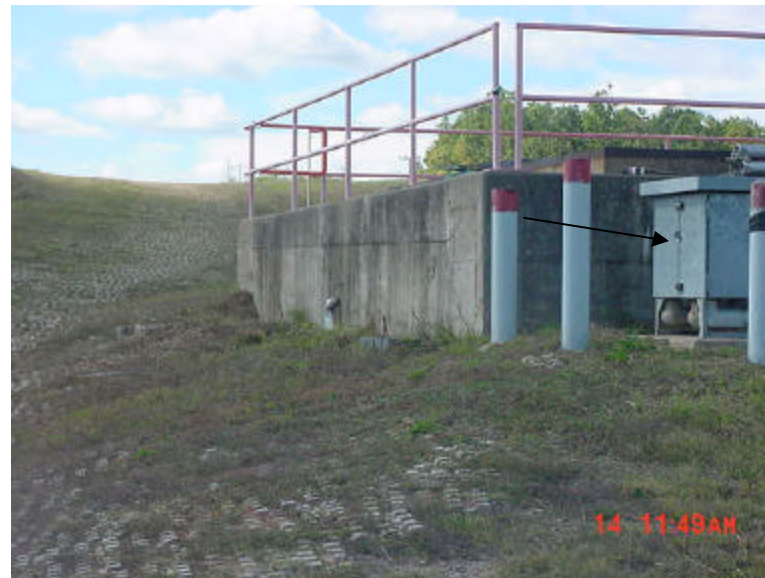
Outfall 114 – Service Water Vault Drain

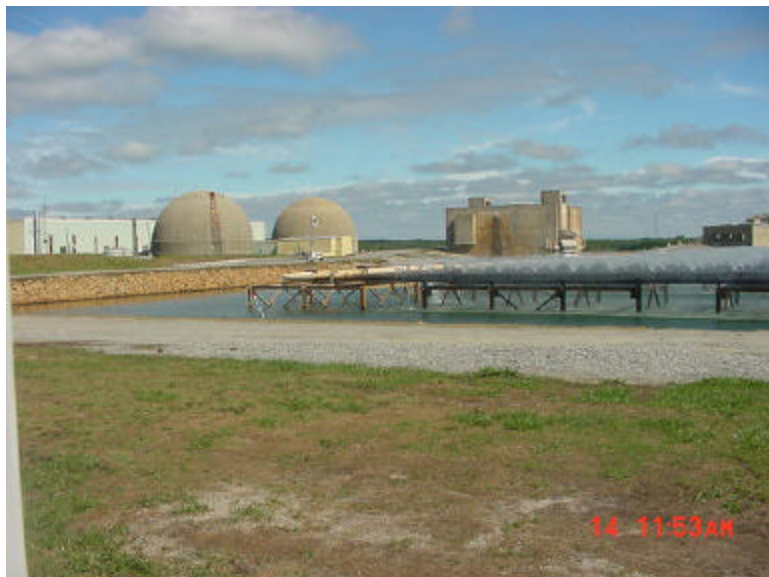
Service water reservoir

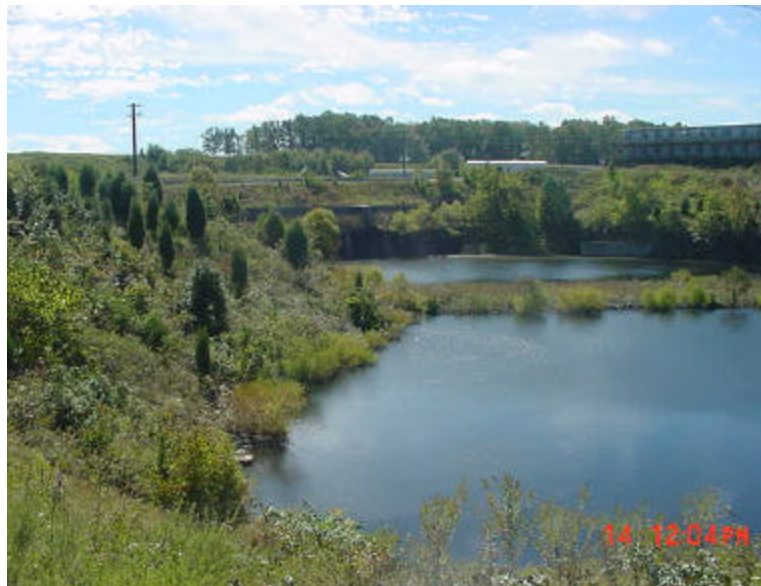
Settling pond leading to Outfall 009

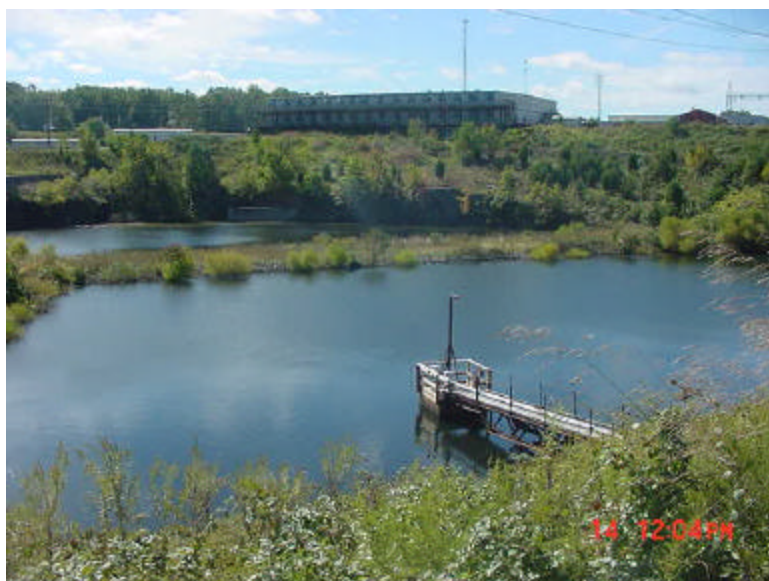
Cont'd settling pond leading to Outfall 009

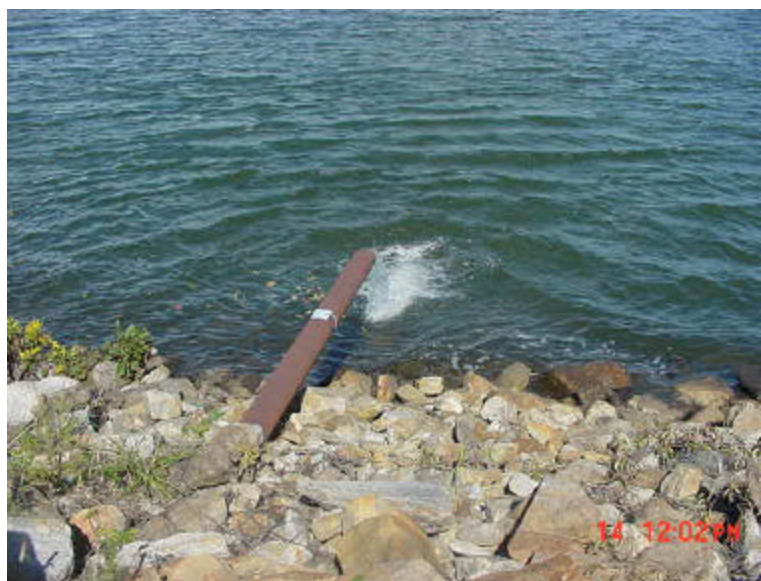
Outfall 009 - Pipe leading from settling pond

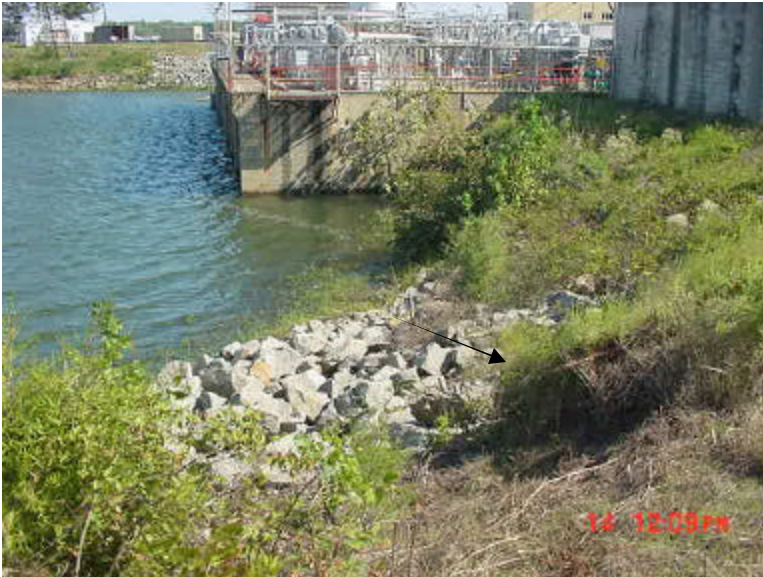
Outfall 014 – Mr. Cooke requested the outfall to be waived from sampling because there are no industrial activities for the outfall, and the discharge could be represented by the storm water sampling.

Outfall 014 – Storm water only

Outfall 014 sampling has changed to be consistent with storm water outfall sampling. With this permit cycle, Outfall 014 has been deemed to release storm water only from the back half of the outside of the turbine building. No industrial influence occurs.

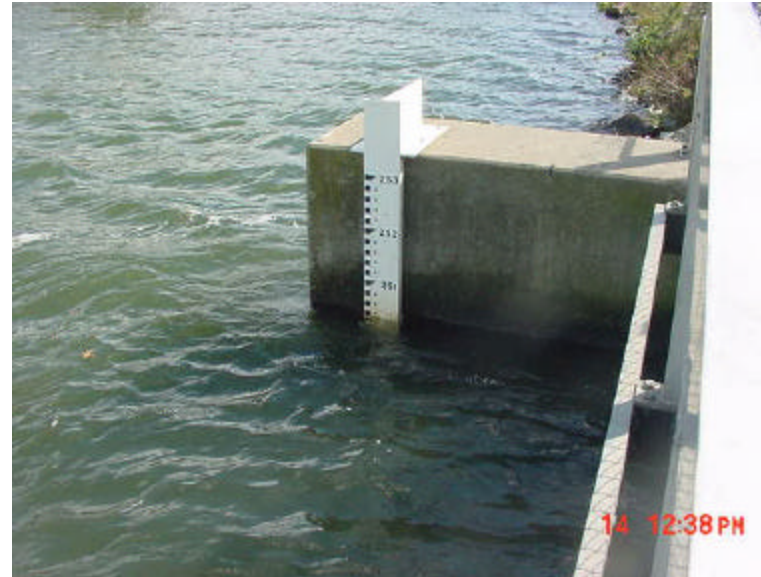
**Observed:** On the day of the visit, Outfall 001 at Dike 3 showed water levels at 250 ft. on the cold side, and 250.6 ft. on the hot side.

Outfall 001 (at Dike 3) – View of water level on side of Lake Anna – 250 ft.

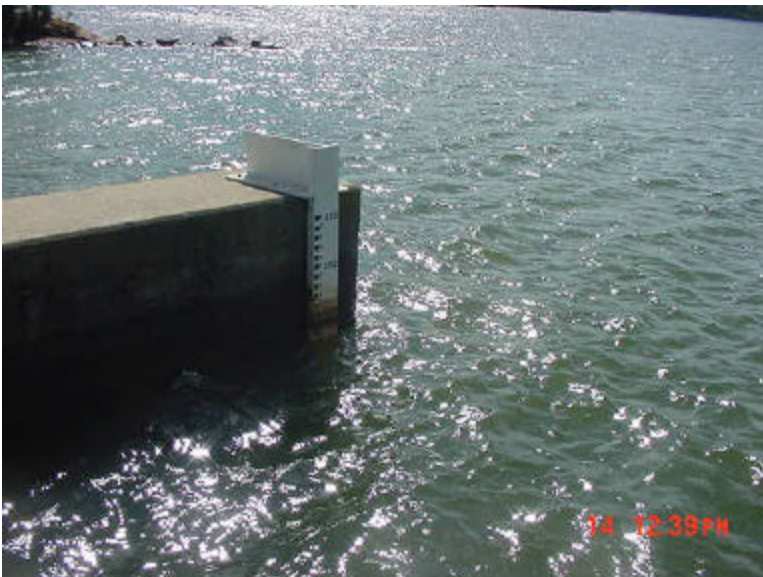
Outfall 001 (at Dike 3) – View of water level on side of Lagoon 3 – 250.6 ft.

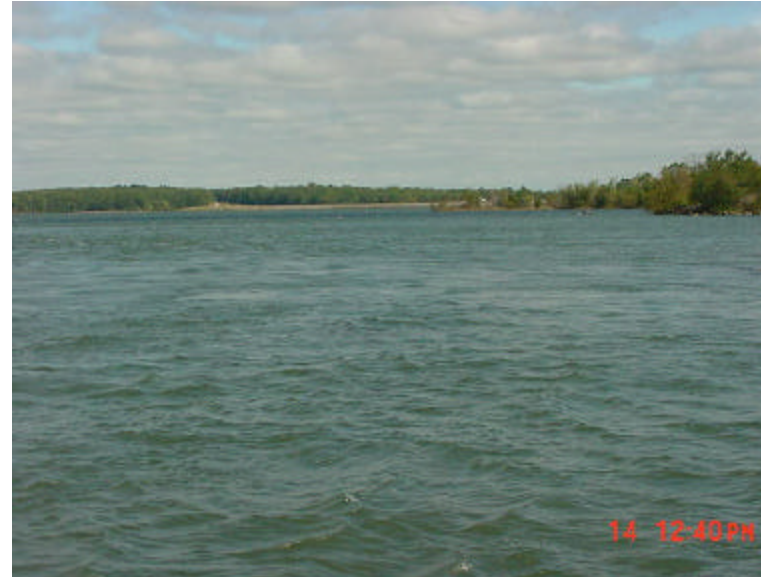
Lake Anna beyond Dike 3, with dam seen in distance

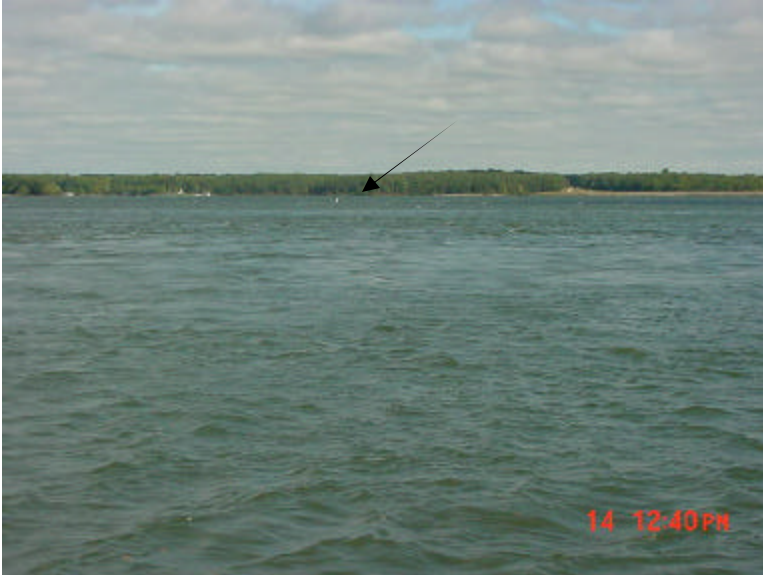
Another view of Lake Anna beyond Dike 3. Temperature monitored at buoys at arrow towards dam.
